Westinghouse Astronuclear Laboratory

WANL-TNR-224

NRX-A6 FINAL REPORT

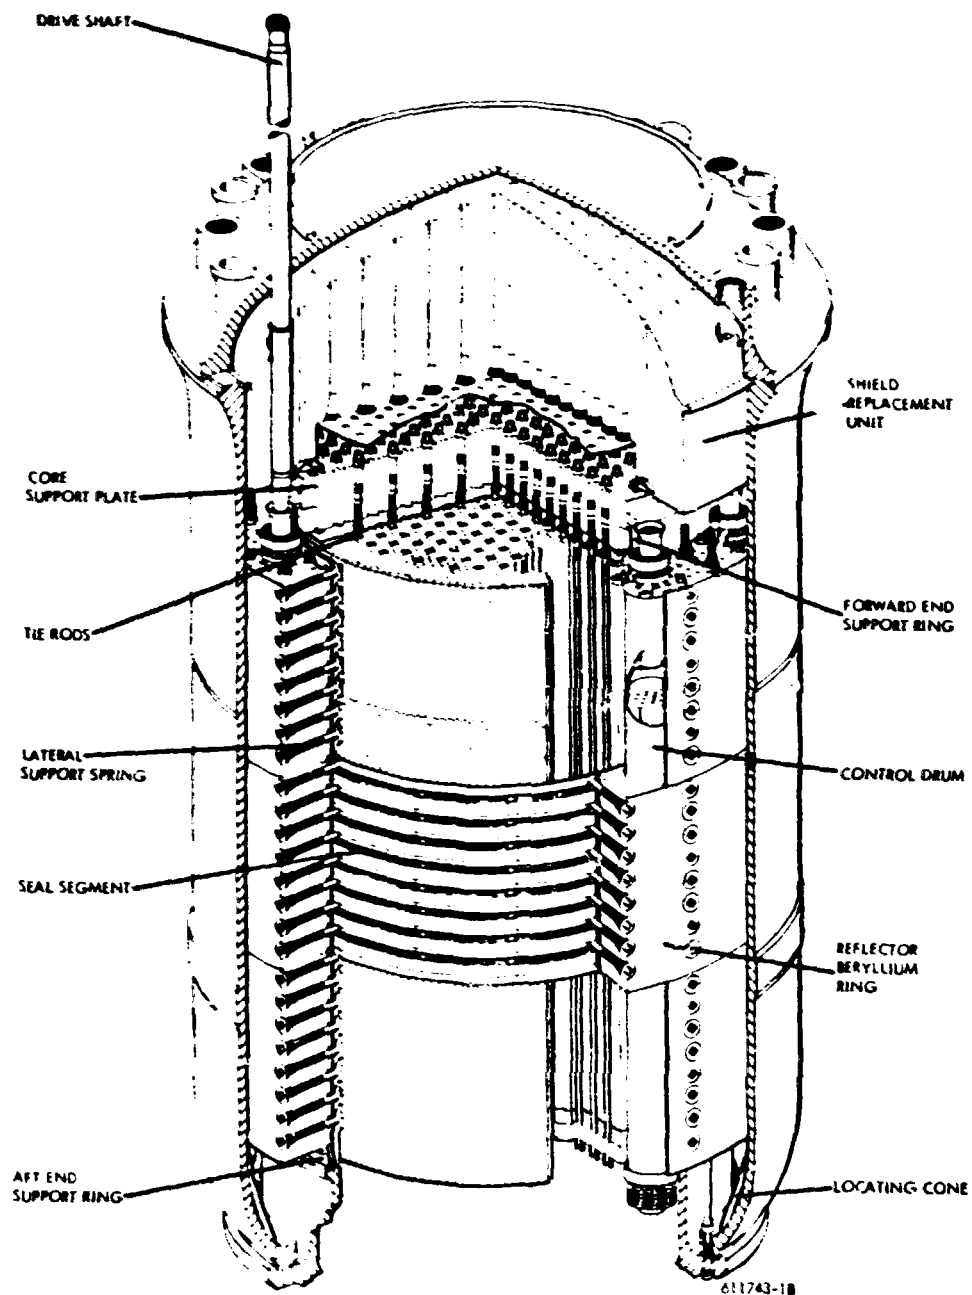
Figure 3-1. (CRL) NRX-A6 Reactor Configuration (U)

(U) The following subsections present a brief description of the principal NRX-A6 reactor components and identify the major design changes from the NRX-A5 reactor. A more detailed description of the reactor may be found in References 6 and 7.

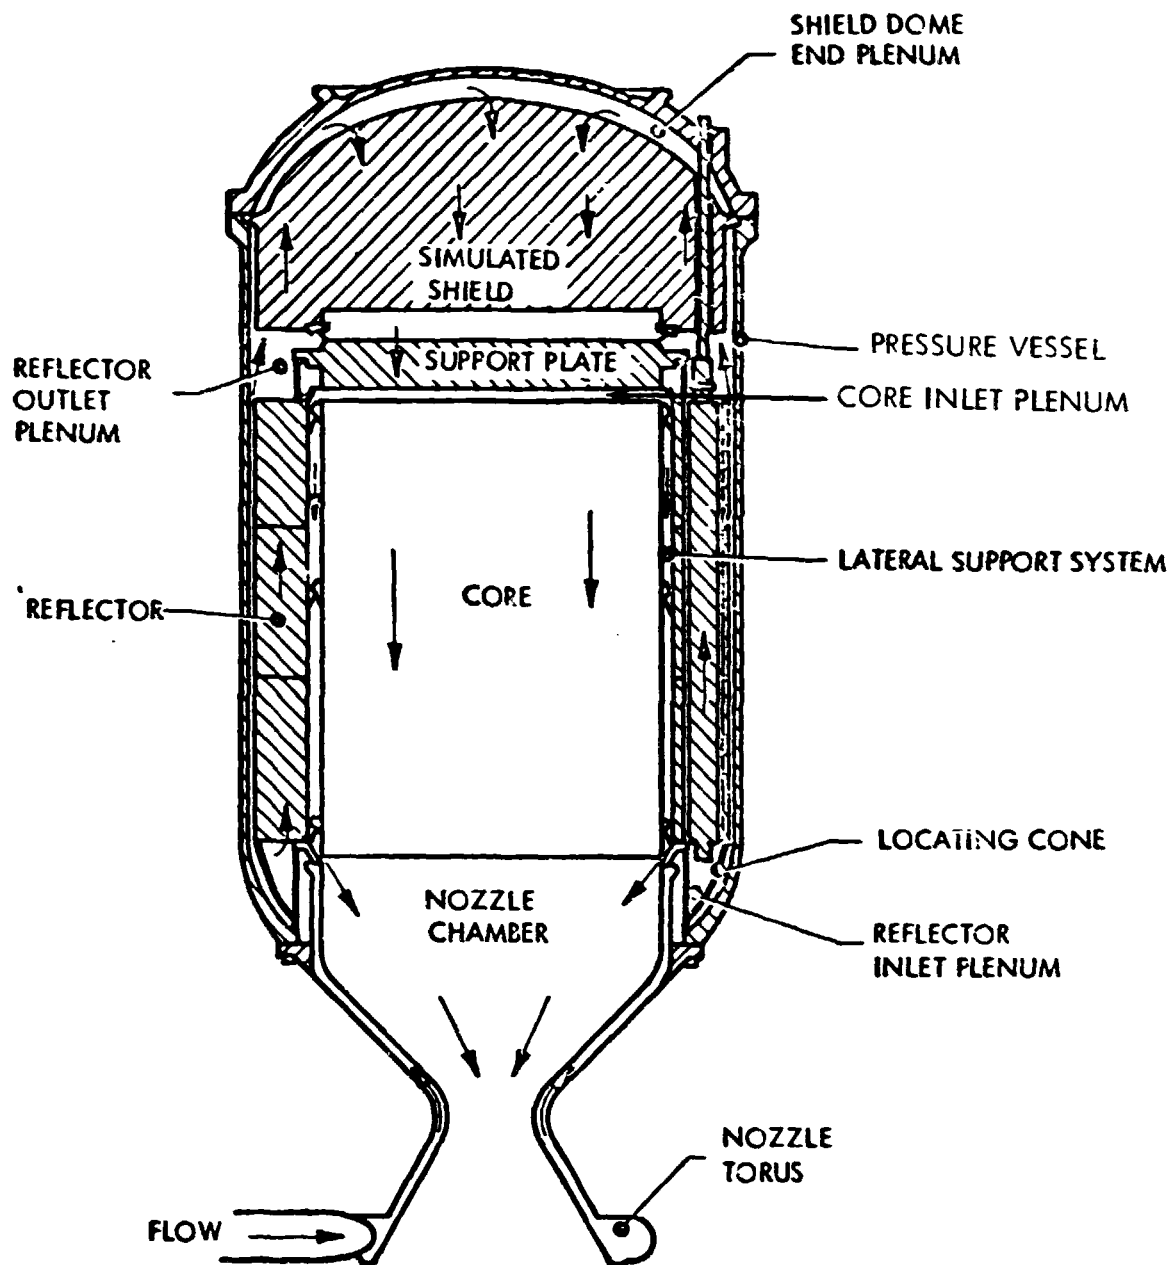
Figure 3-2. (CRD) NRX-A6 Reactor Flow Path (U)

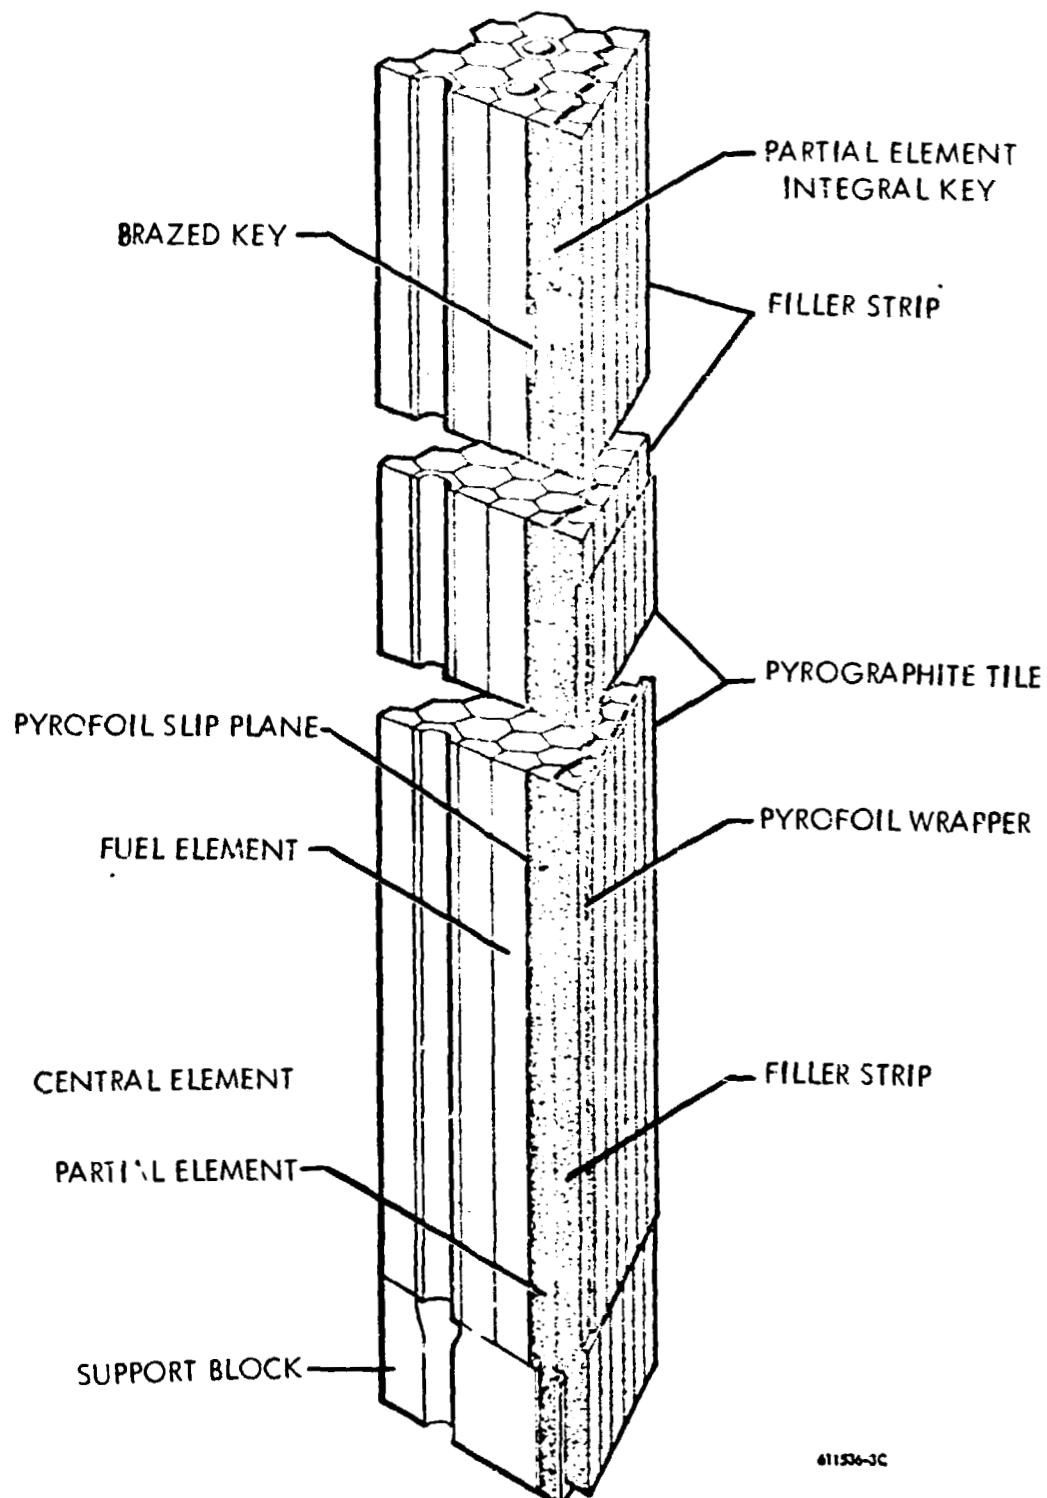
Figure 3-3. (CRD) Trimetric View of Filler Strip Periphery (U)

(CRD) To insure that the filler strips could survive the expected startup and shutdown transient conditions, the average steady-state gap between filler strips (Station 12 to 48) was increased from 0.0005 inches (NRX-A5) to approximately 0.0030 inches. This was expected to minimize circumferential bridging between filler strips even during emergency shutdown. Also the minimum gap between the filler strip key-ways and forward ledge of the keys on the elements was made equal to the maximum possible gap between the aft end of the filler strips and the support ledges. This was designed to prevent the filler strips from axially loading the forward edge of the keys by providing adequate axial clearance.

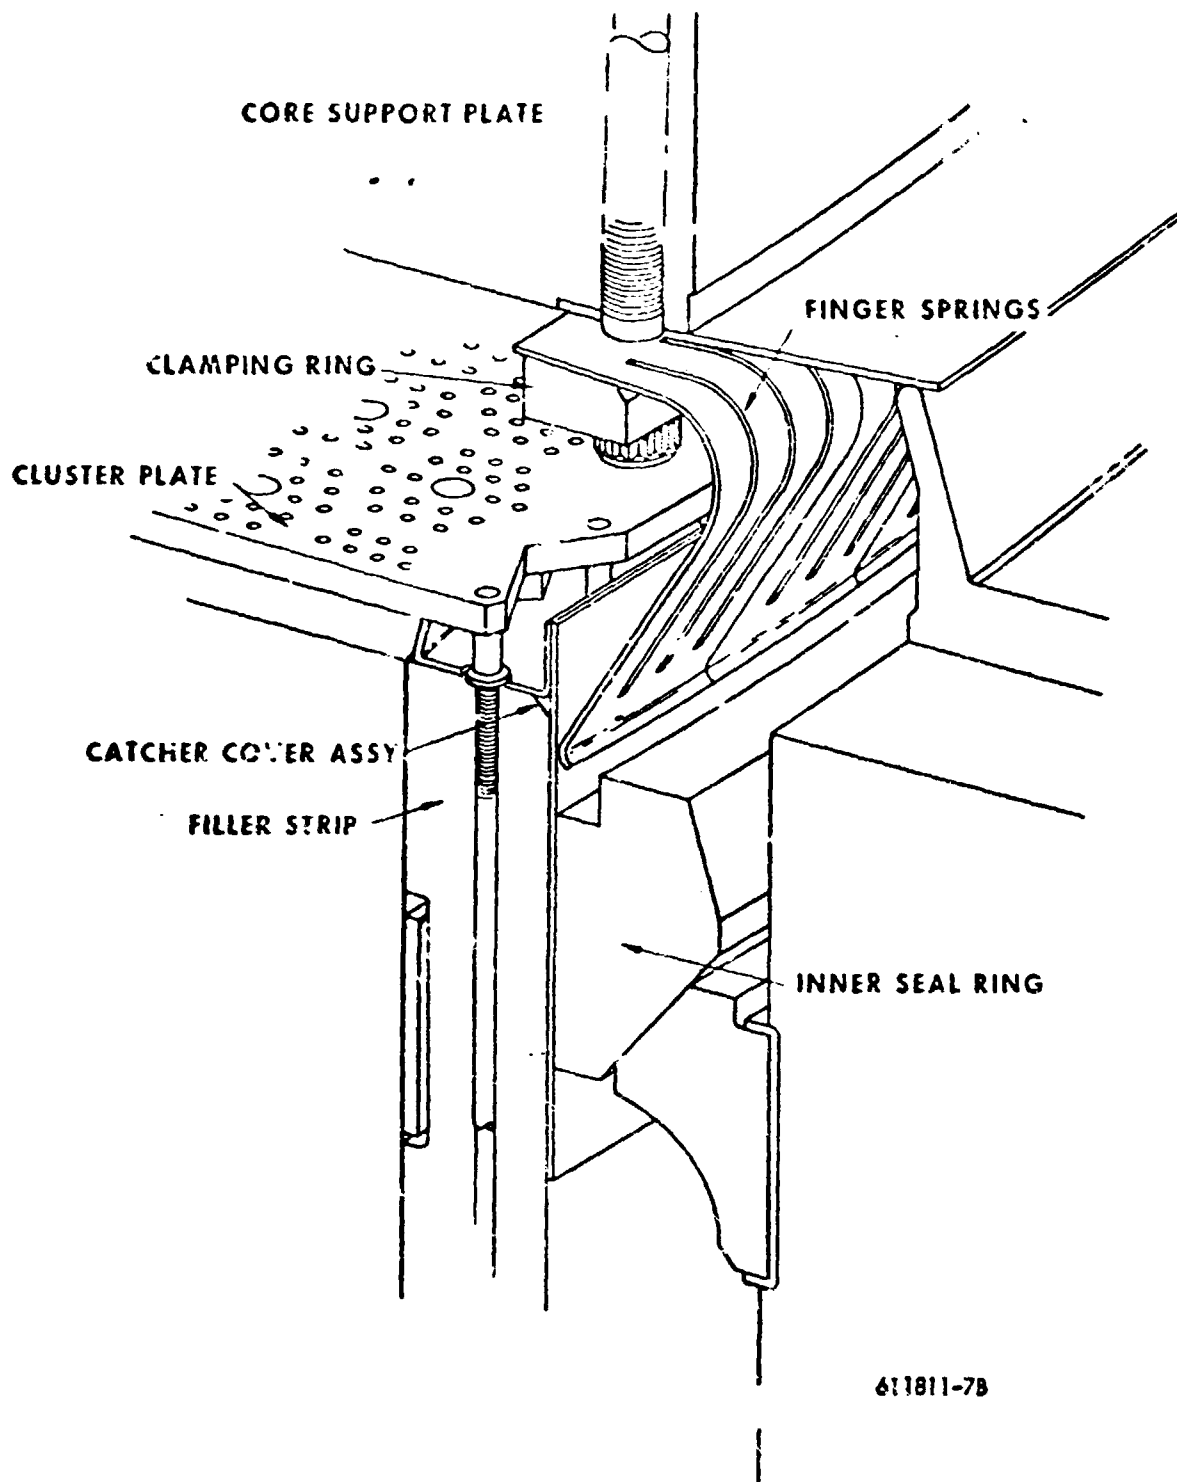
Figure 3-4. (CRD) NRX-A6 Particle Catcher (U)

(CRD) In the NRX-A5 reactor test, particles of graphite from broken forward ends of the filler strips had entered the core inlet plenum between the core support plate and forward ends of the filler strips. These particles became lodged between the core support plate and cluster plate, ultimately resulting in severe local overheating and accelerated corrosion of a fuel element and support block. In the NRX-A6 reactor, a particle catcher was incorporated at the inlet end of the core periphery to eliminate this potential problem. The design of the particle catcher is shown in Figure 3-4 and consists of numerous metal finger springs trapped against the aft side of the core support plate by a bolted metal ring. Stress analysis of the particle catcher indicated that the clearance between segments of the particle catcher was sufficient to prevent interference during reactor operation.

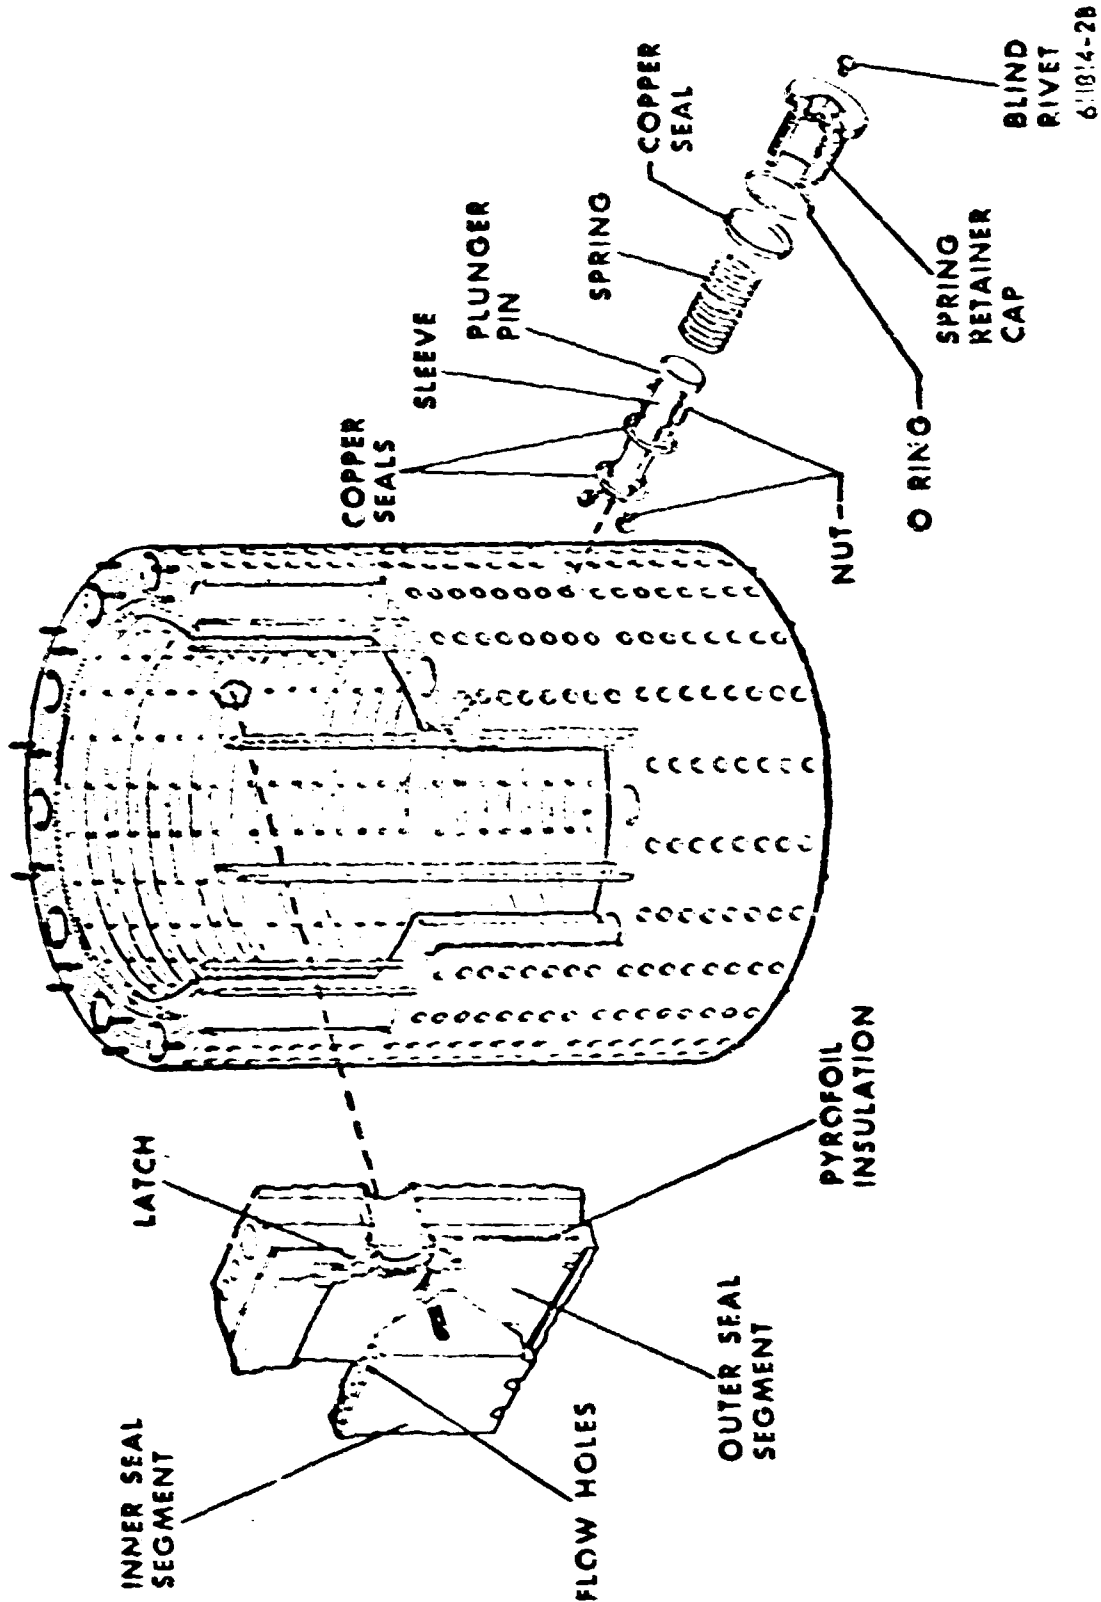
Figure 3-5. (CW) HBY-AF Reflector/Lateral Support Arrangement (U)

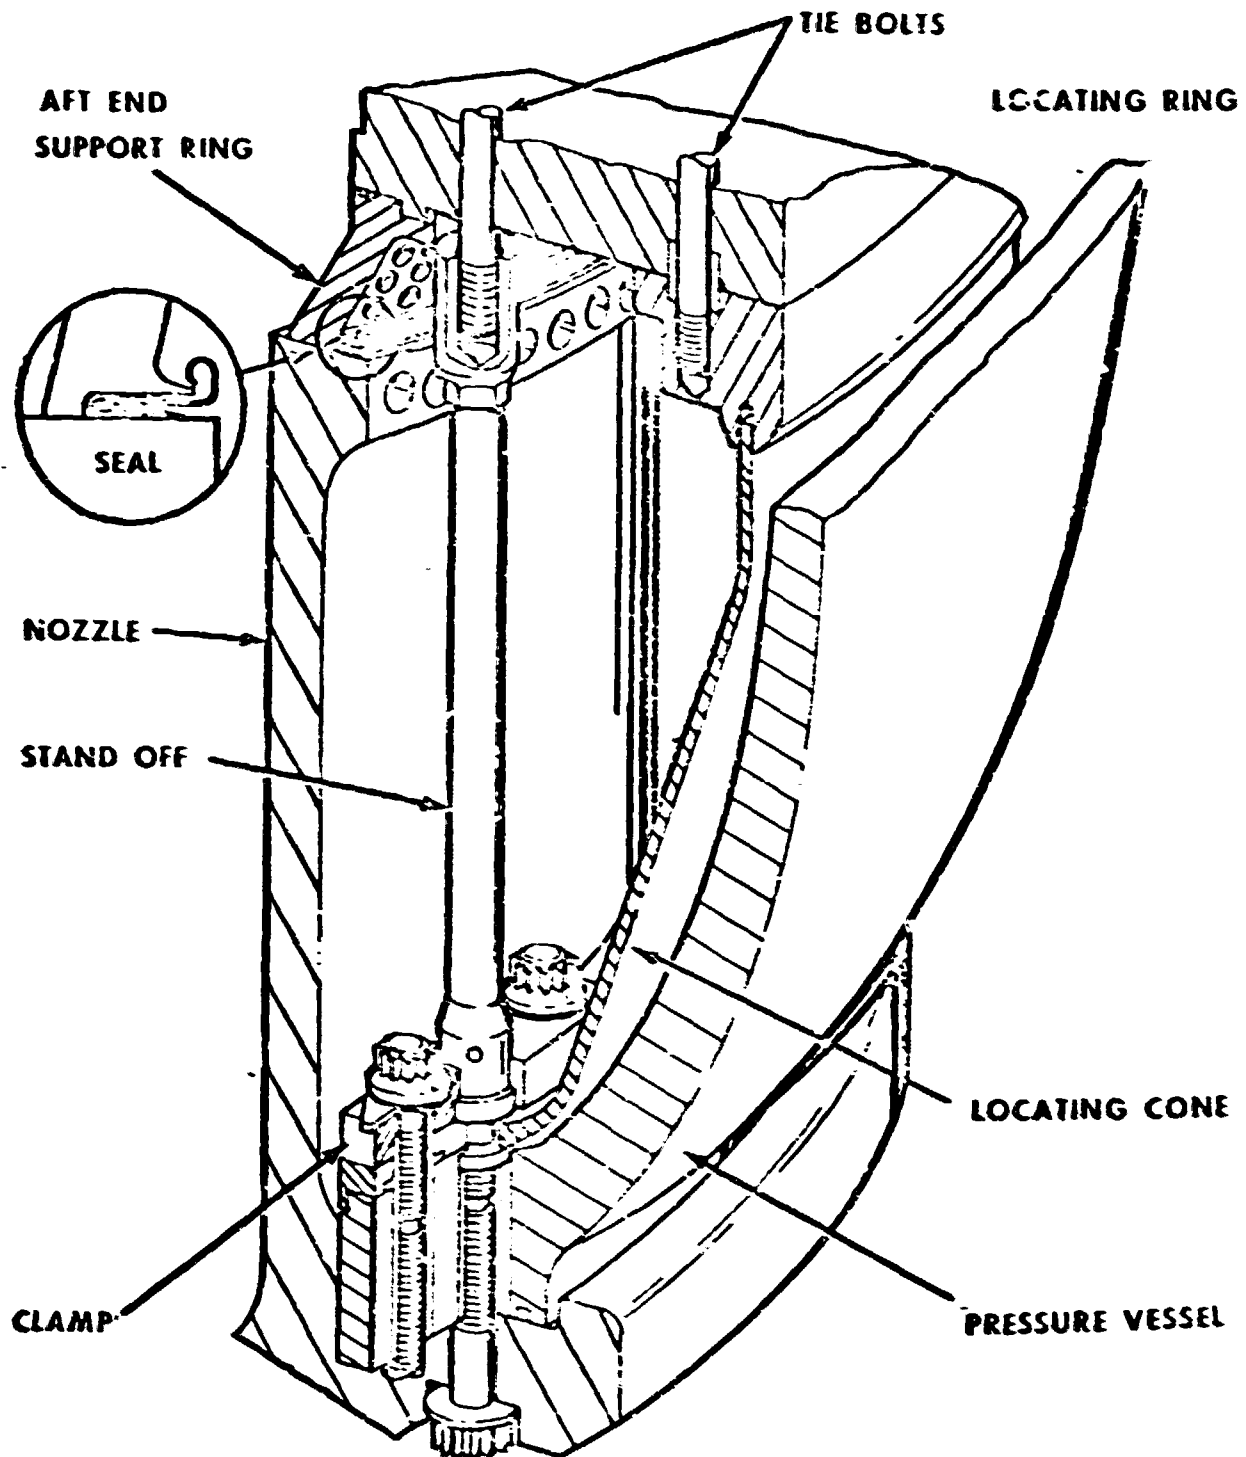
611812-23

Figure 3-6. (CRD) Aft End Support System (U)

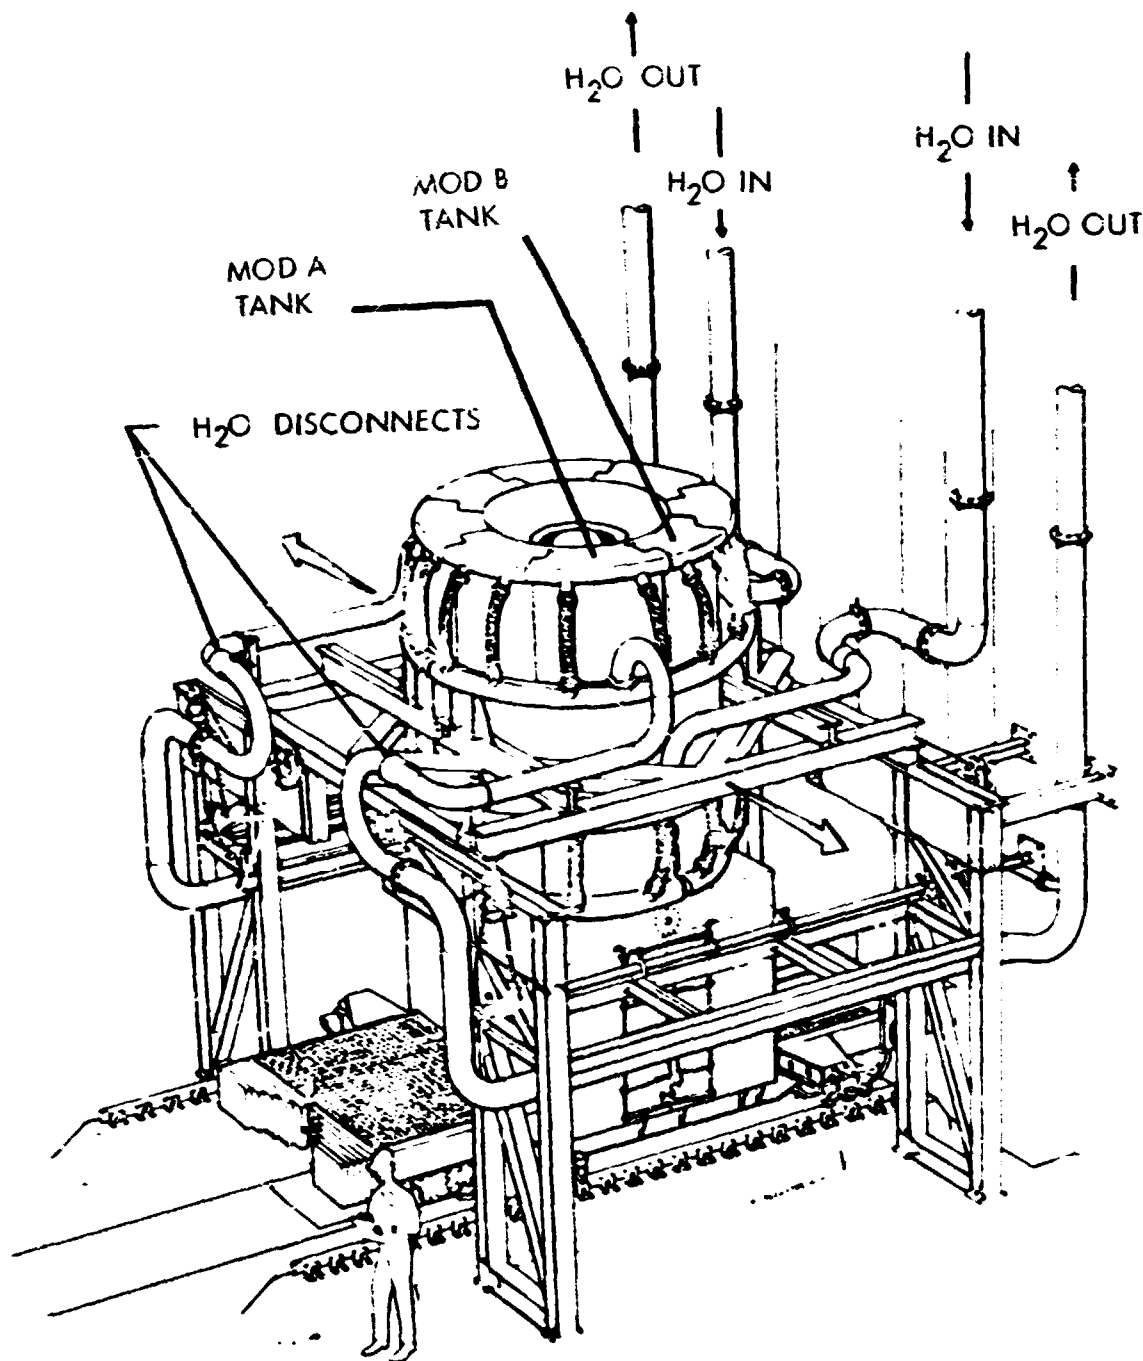
Figures 3-8. (U) Test Cell "C" 360 Degree Shield
(THIS PAGE IS UNCLASSIFIED)

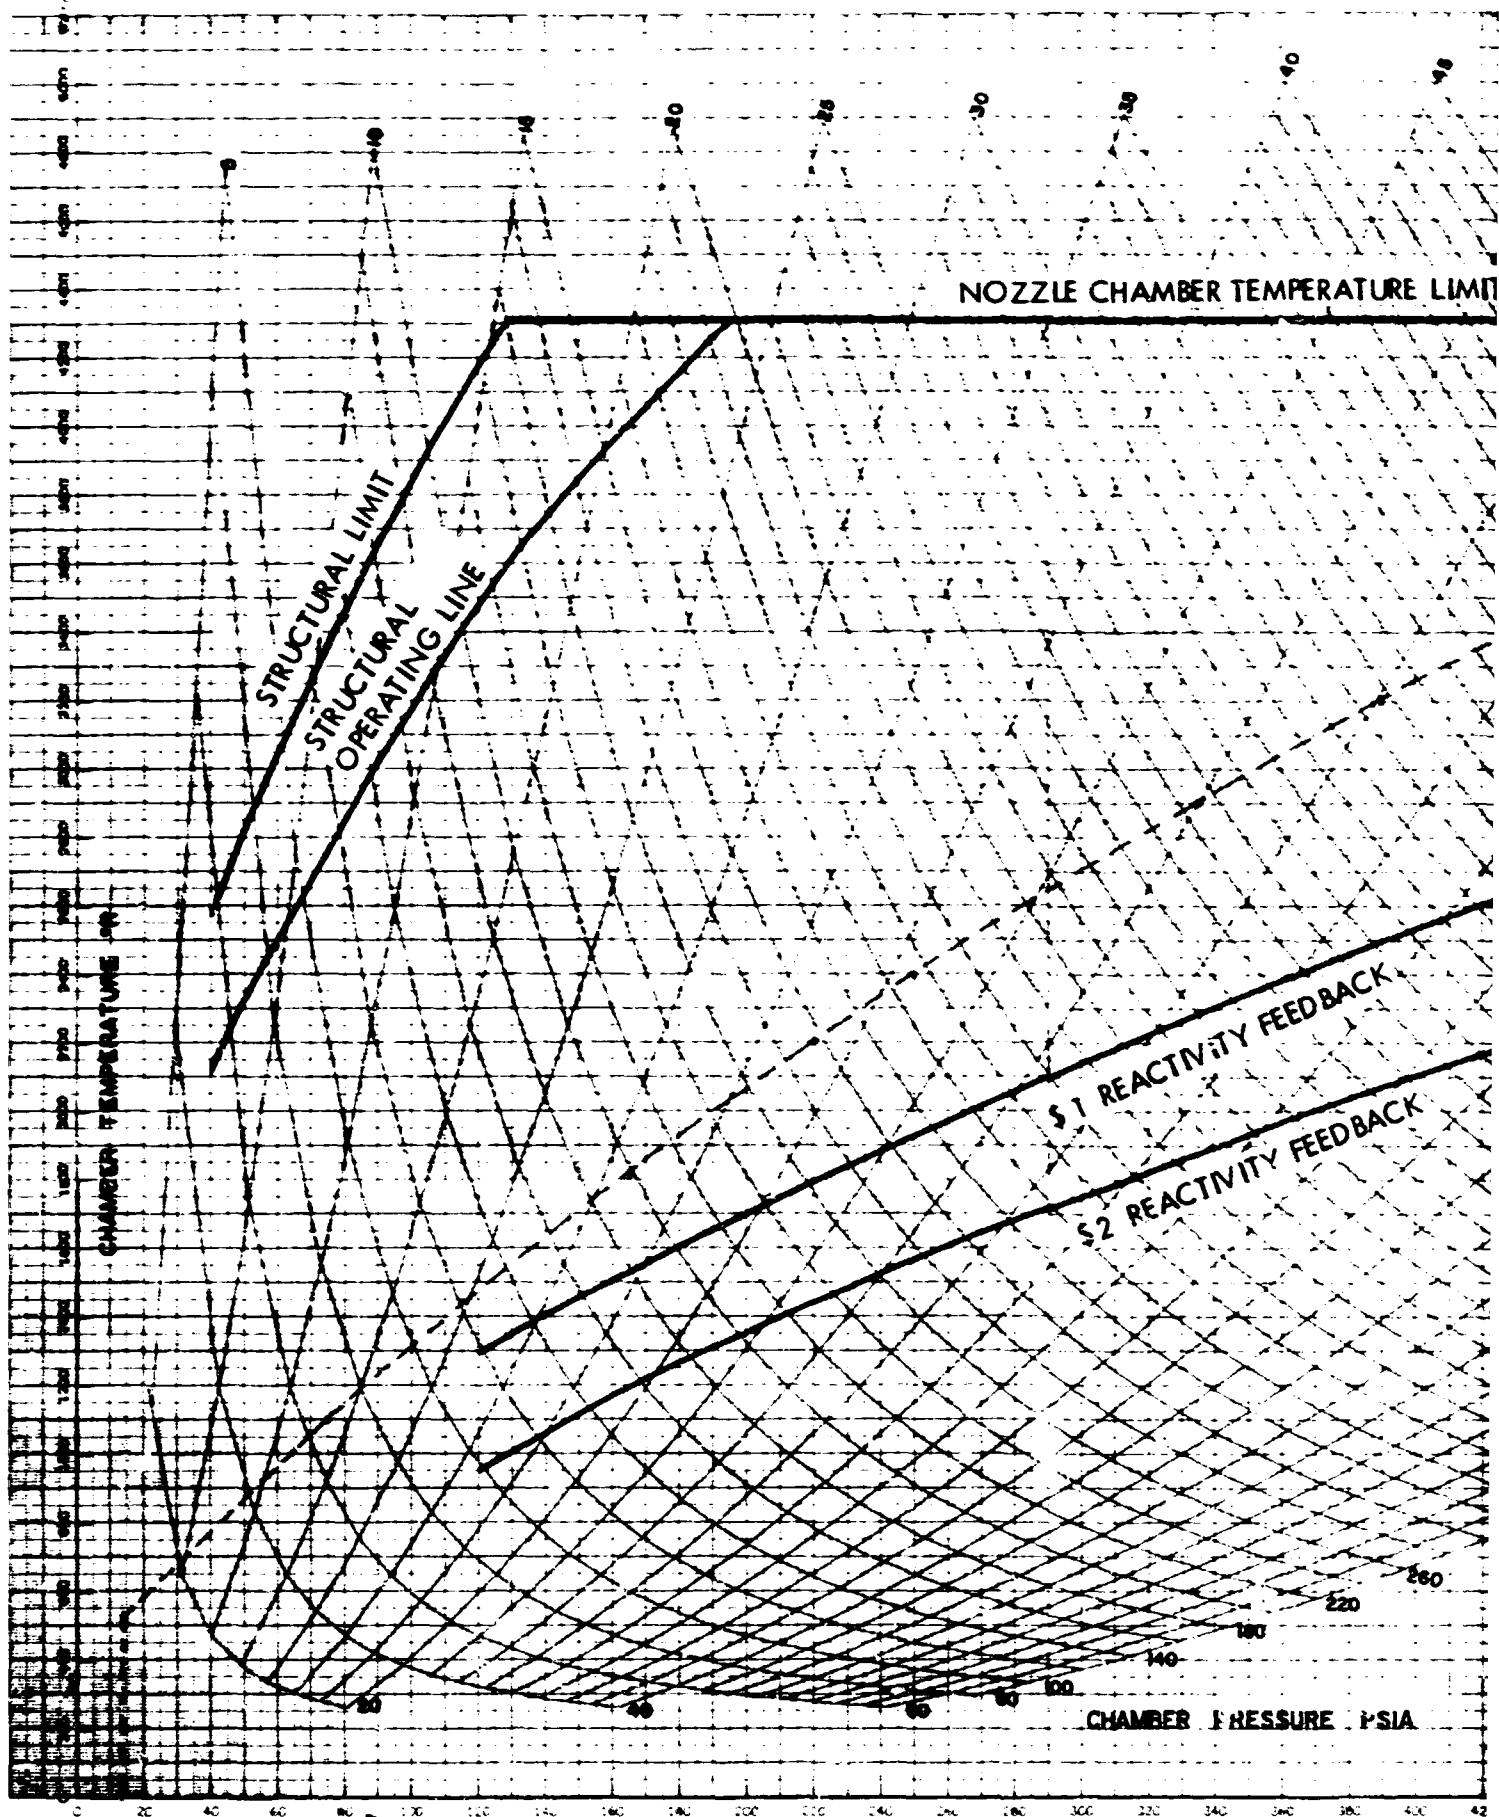
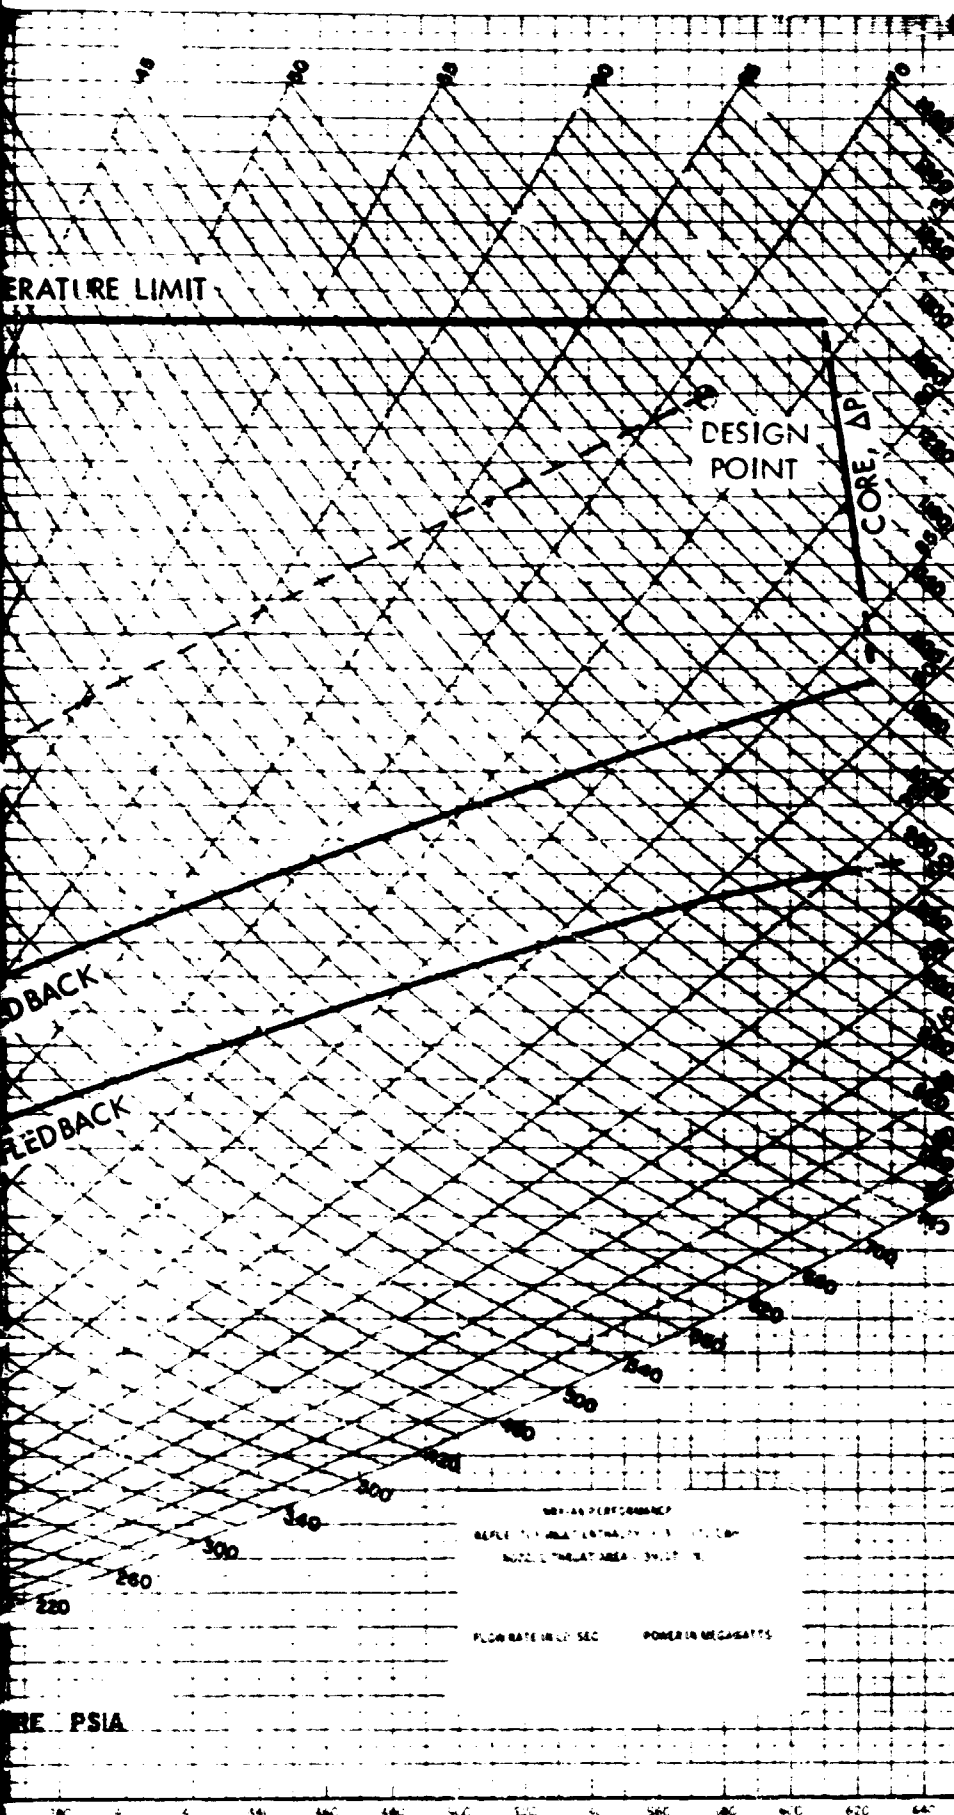
Figure 3-10. (U) NRX-AE Operating Map

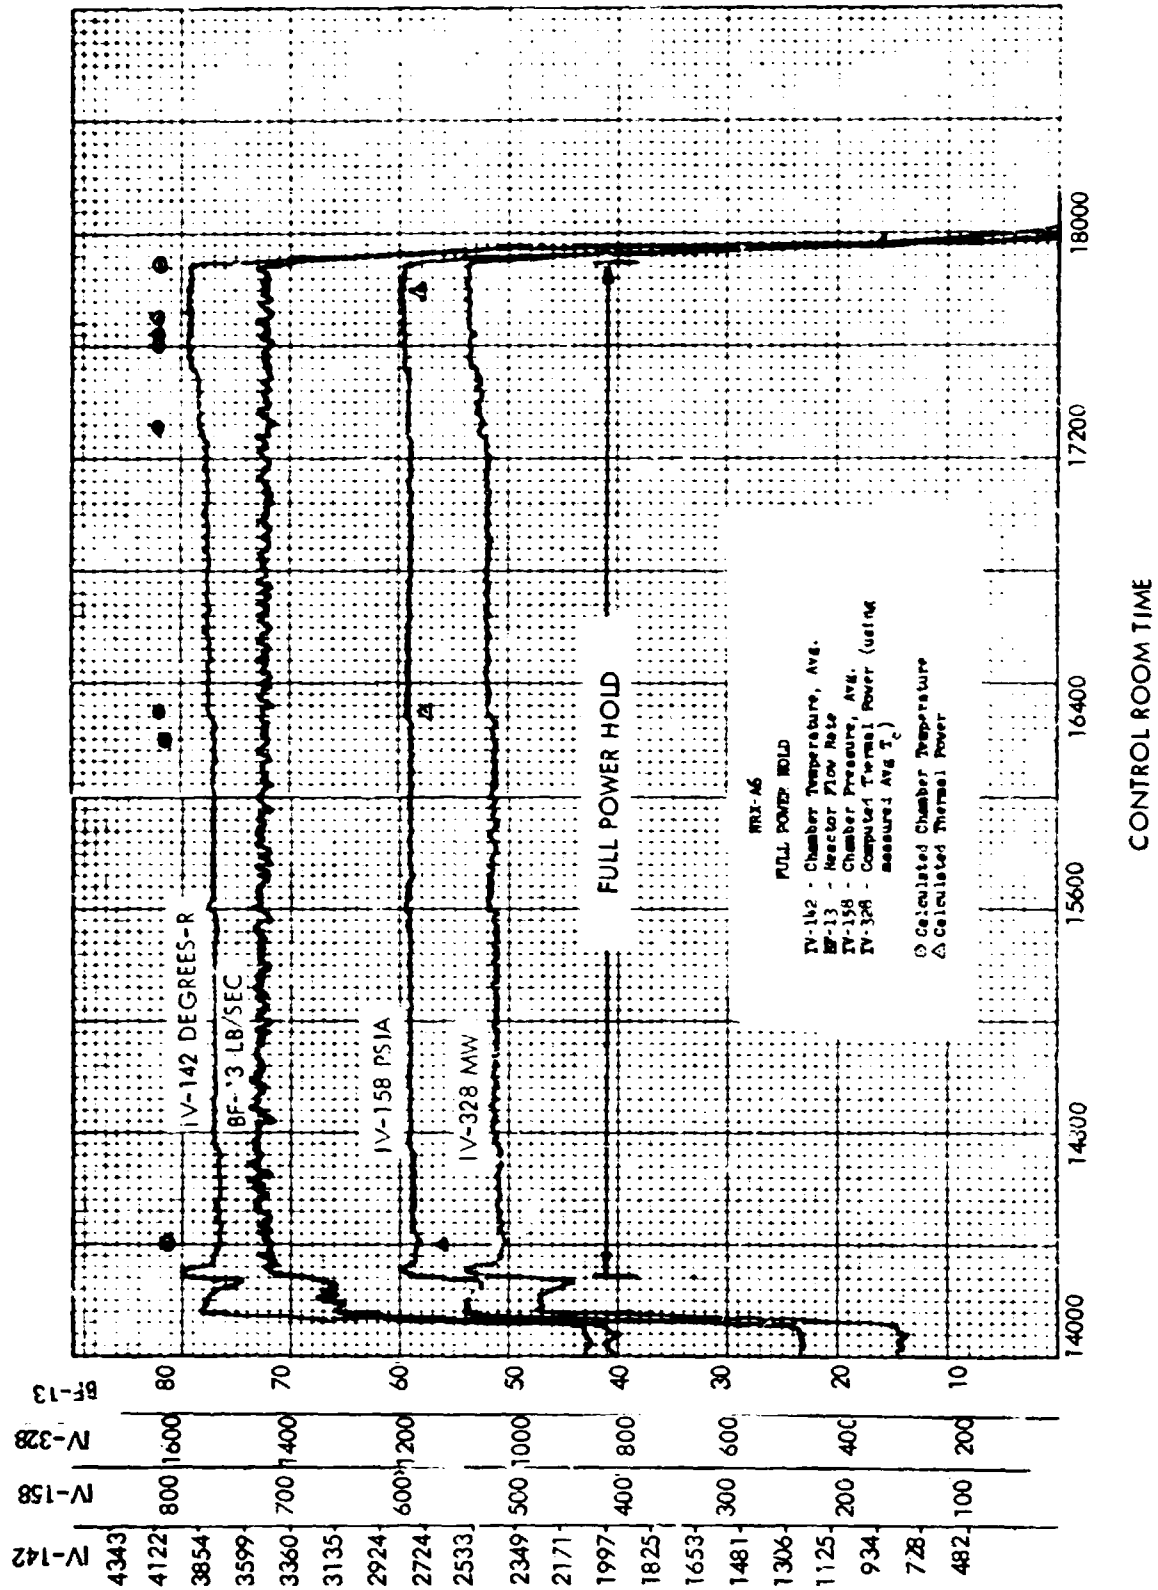
Figure 4-1. (U) NRX-A6 Full Power Test, EP-III A, Parameter Run Time Profile

(U) Reactor performance parameters during the test run and the performance operating map are shown in Figures 4-1 and 4-2, respectively.

(U) Control drum position near the start of the Full Power Hold was 104.5 degrees; at the conclusion of the hold, the indicated drum position was 115.4 degrees. Control drum position near ambient temperature, as determined on the post-run criticality test, was 100.9 degrees; control drum position prior to the Full Power Run was 95.5 degrees.

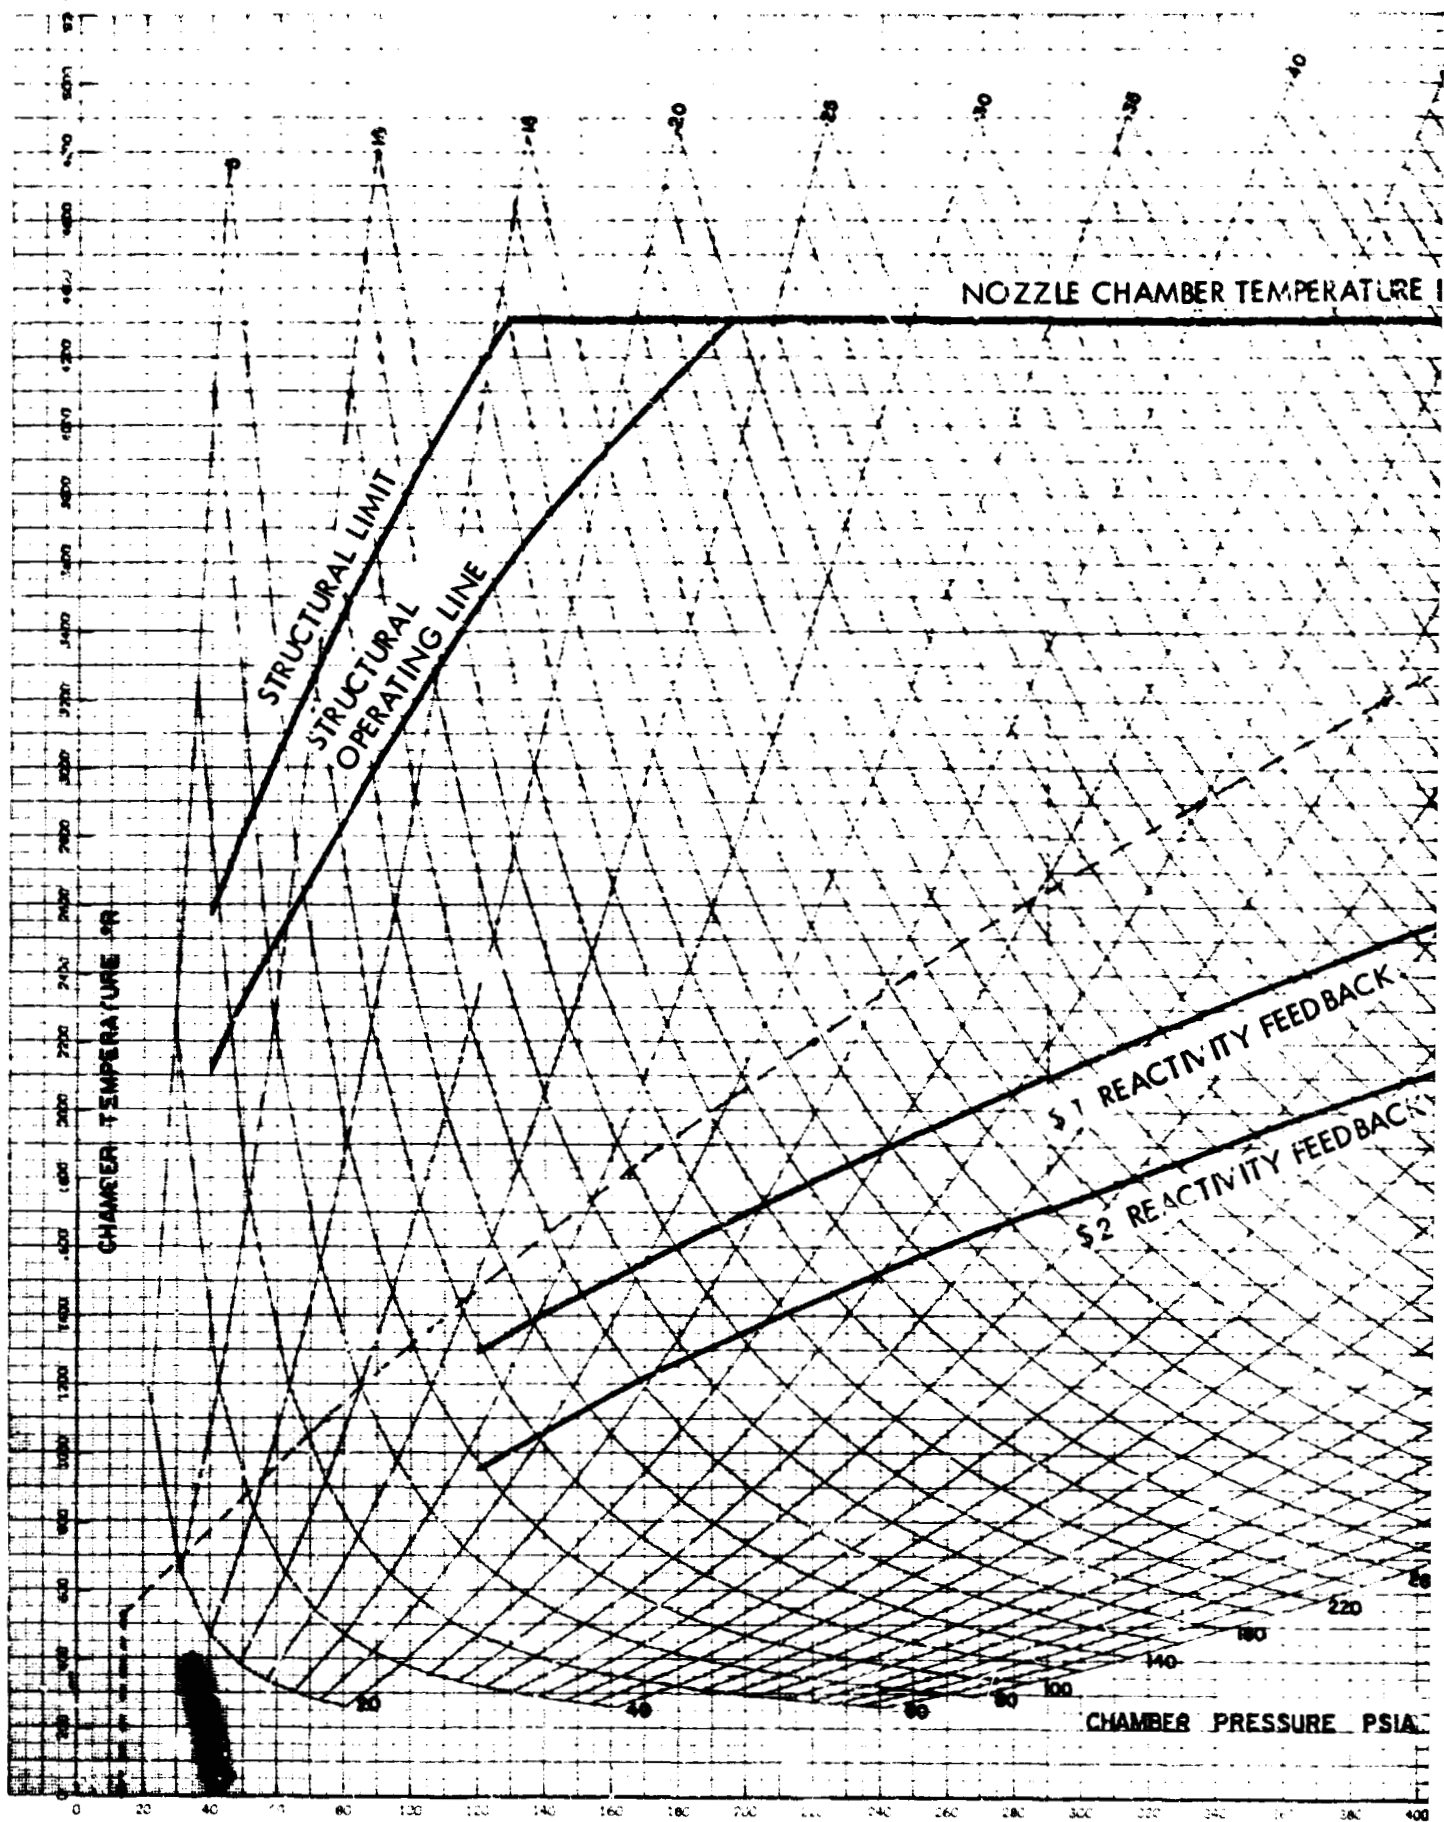
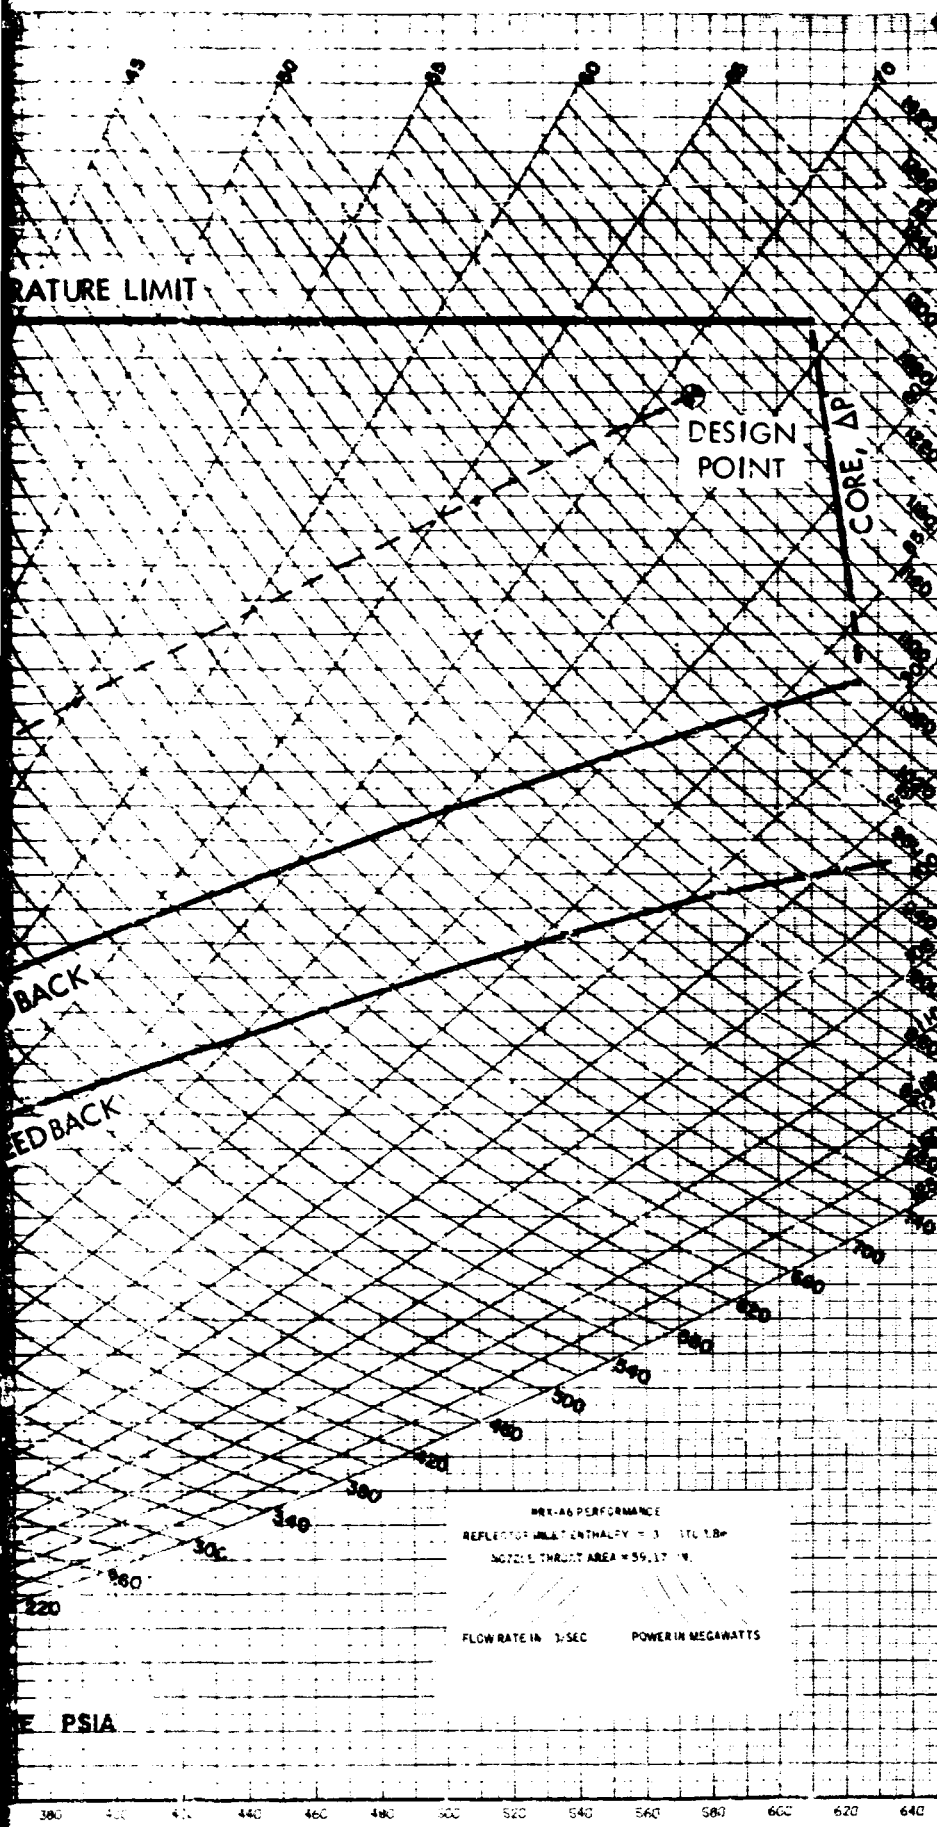
Figure 4-2.
(U) NRX-A6 Full Power Test,
EP-III A, Operating Map
